Informational Summary Report of County of Los Angeles Fire Department (LAC) Serious or Near Serious Injuries, Illnesses, and Accidents

Firefighter Line of Duty Death

Unnamed Truck/RV Fire

Incident Number LAC 24-203895

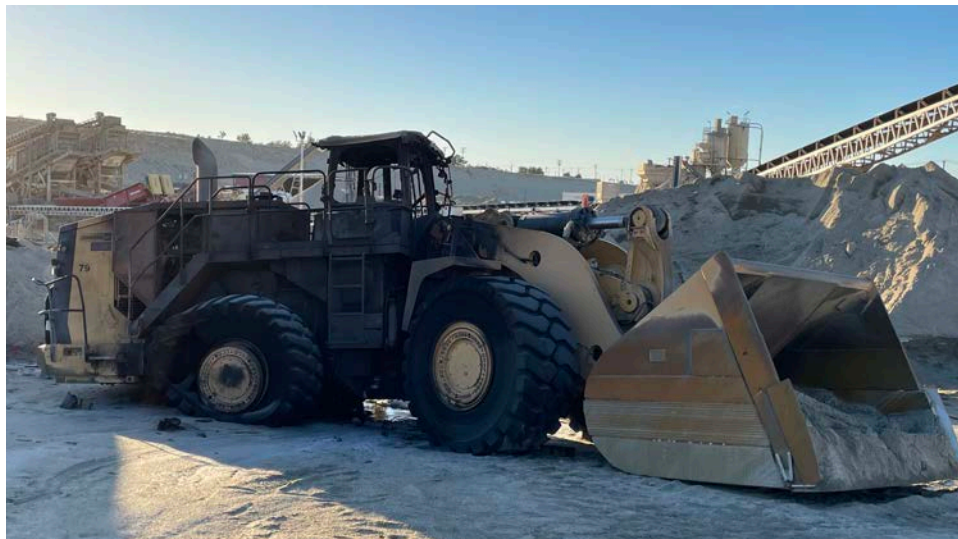
Right side of wheel loader

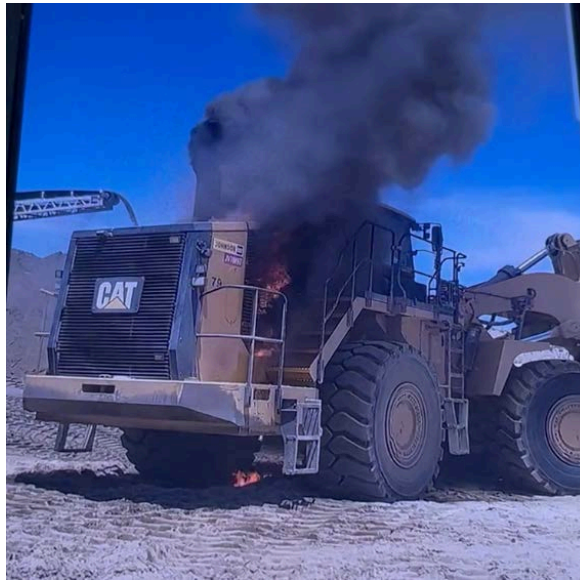
Fire in engine compartment

Fire was visible burning in the engine compartment and on the ground around the rear tires by 1338 hours. Quarry personnel attempted to extinguish the fire utilizing the quarry's 3000 gallon water tender beginning at 1346 hours. The fire was not extinguished, and all quarry personnel were evacuated to approximately 120 feet from the wheel loader.

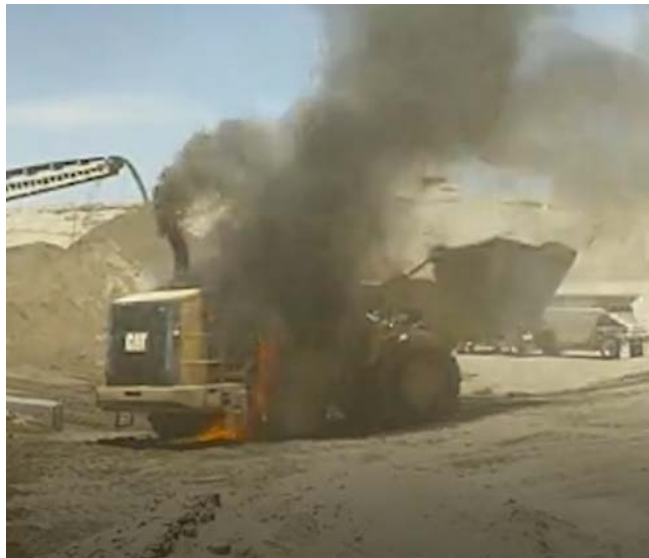
- Fire was first discovered by quarry personnel in the engine compartment of the wheel loader located at the rear of the vehicle.
- Burning material fell to the ground below the engine compartment.
- The burning material ignited the right-rear and then the left-rear tires.

Fire extending to the right-rear tire at 1441 hours.

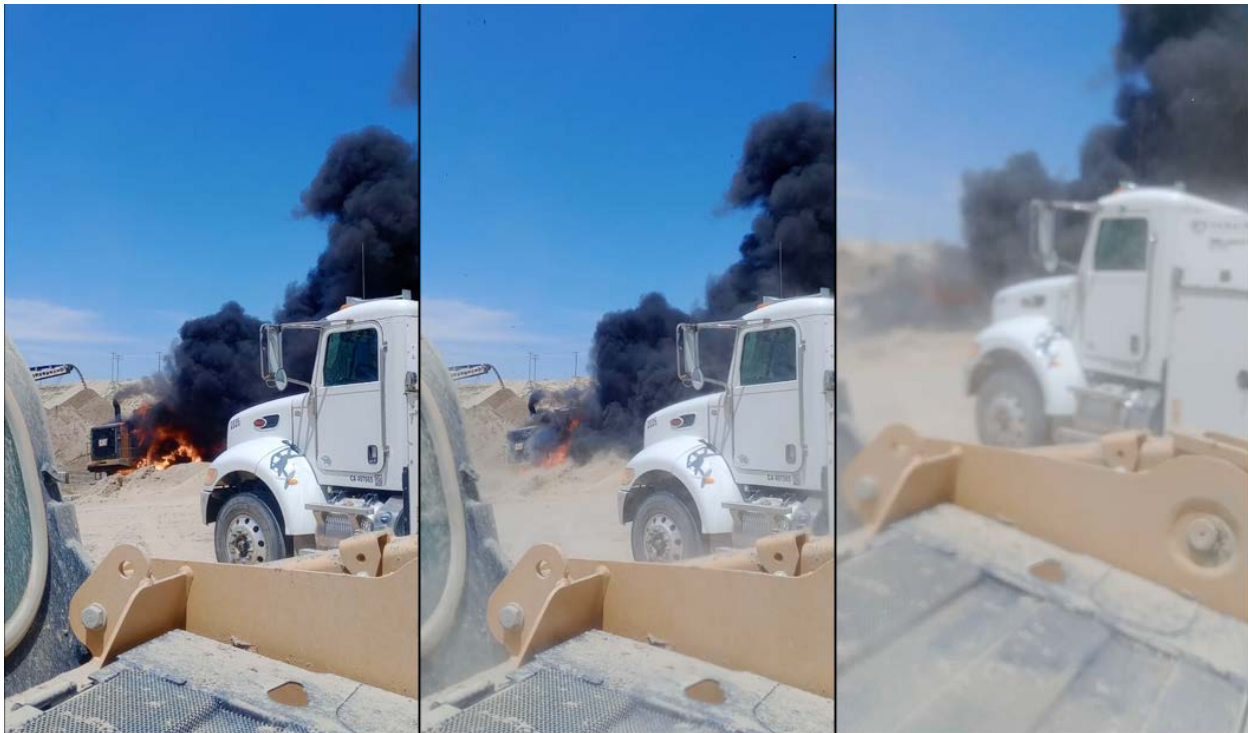
Right-rear tire explosion prior to FD arrival. The windshield of the white truck was broken during the blast.

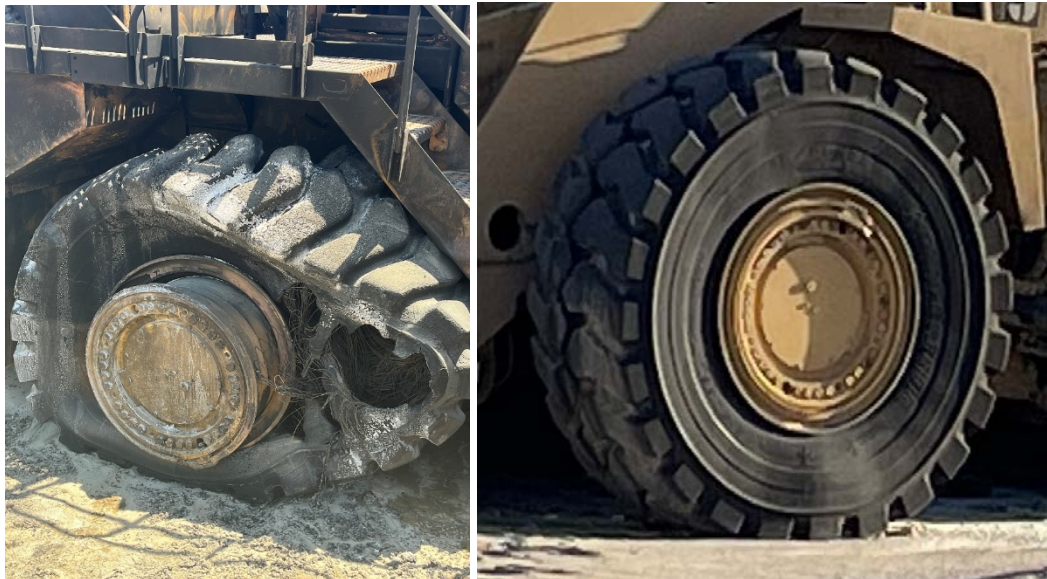
The left-rear tire exploded at 1408 hours. This explosion occurred:

The force of the explosion expelled debris up to 350 feet from the left-rear tire. The left-rear tire explosion was more powerful than the right-rear tire explosion. Only the rubber and steel cord components of both tire's sidewalls were expelled during the explosion; the multi-piece rim assemblies remained intact.

Left rear tire (left photo) and left-front tire (right photo)

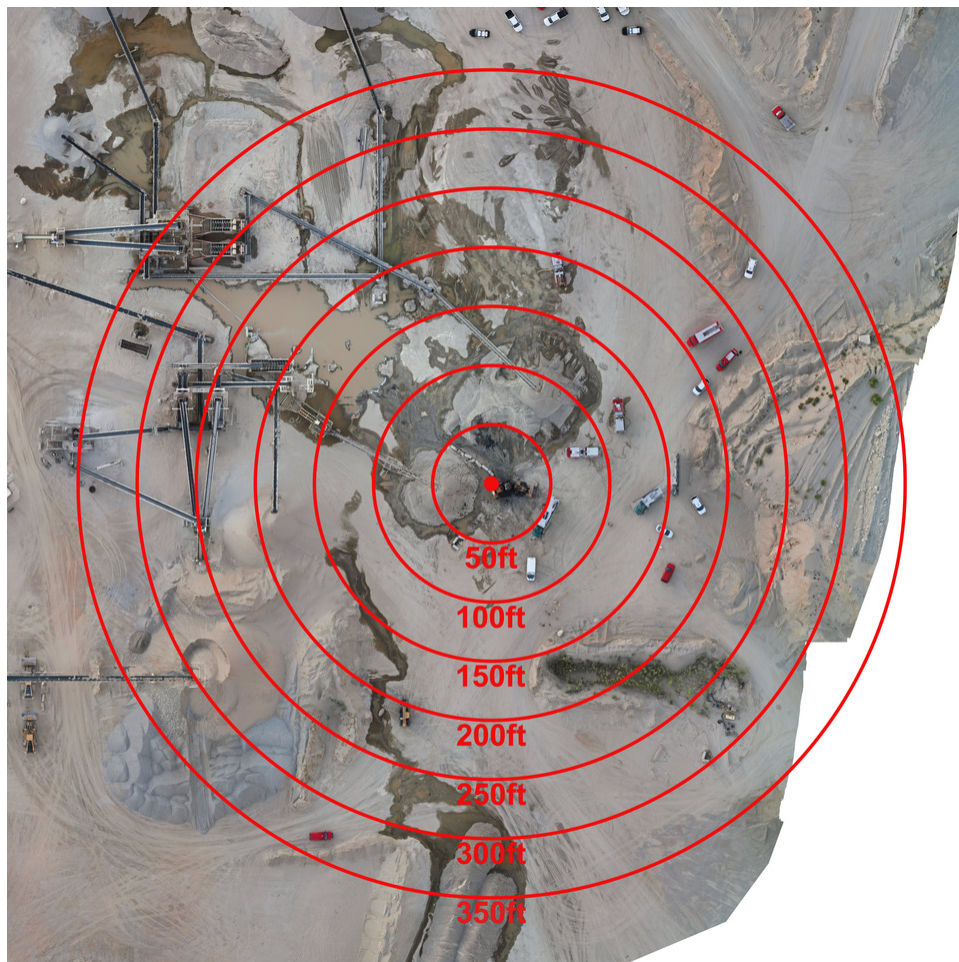
Scaled overhead photo illustrating maximum distribution of debris.

When the incident priorities do not require operation within any of the explosive hazard zones, personnel shall be kept a minimum of 350 feet away from the tire. As discussed in the previous section, extinguishing the fire exposing or burning the outside of the tire may not stop the exothermic reactions inside the tire and an explosion may still occur. Personnel and civilians shall be aware and not immediately approach a tire which has been exposed to significant heat.

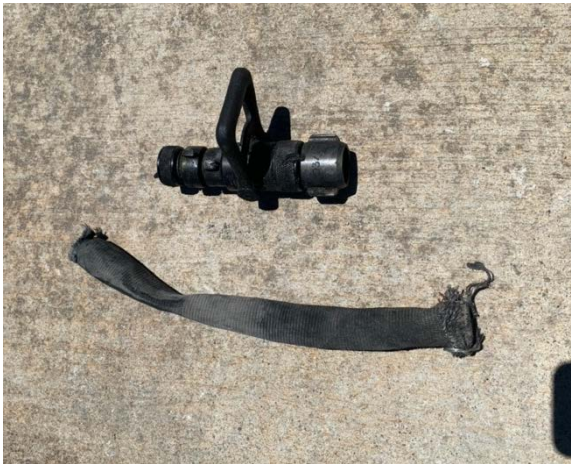
- FF1's personal protective equipment, including radio and SCBA, were destroyed.
- One 1-inch reel line was destroyed.
- One 1-inch 10/40 gpm dual gallonage nozzle was destroyed.
- E93's engineer side windshield was broken.

1-inch hose and nozzle

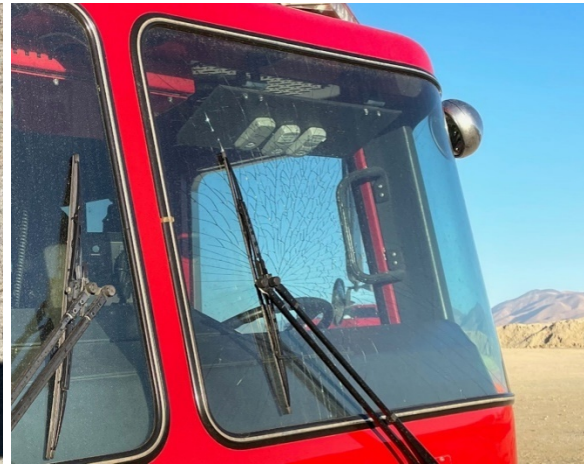
Broken windshield

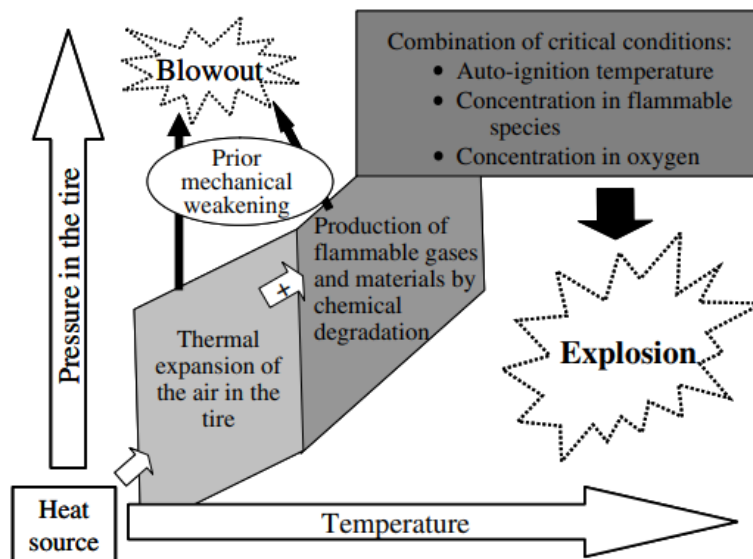
Processes leading to tire blowout or explosion (Dolez et al., 2007)

There are three phases of the process that may lead to the explosion of tires exposed to heat. First, the air pressure inside the tire will increase as the temperature rises. The pressure of a tire inflated to 90 psi will rise to approximately 235 psi. Unless there is a mechanical defect within the tire or rim assembly, the pressure increase due to the expansion of the air inside the tire will not typically lead to failure (blowout).

Second, when the rubber of the tire reaches 365° Fahrenheit, it will undergo thermo-chemical degradation reactions and release gases within the tire. The gases released are added to the quantity of air already inside, increasing the pressure within the tire. There are two important things to note regarding these thermo-chemical degradation reactions:

Third, an explosion will occur when the oxygen concentration is at least 5.5 percent and the flammable gases reach their lower explosive limit and auto-ignition temperature. The explosion will generate shock waves and pressures over 1000 psi, projecting fragments outward at high velocity that travel great distances.
